BATTERY SPACER PLATE'S FATE

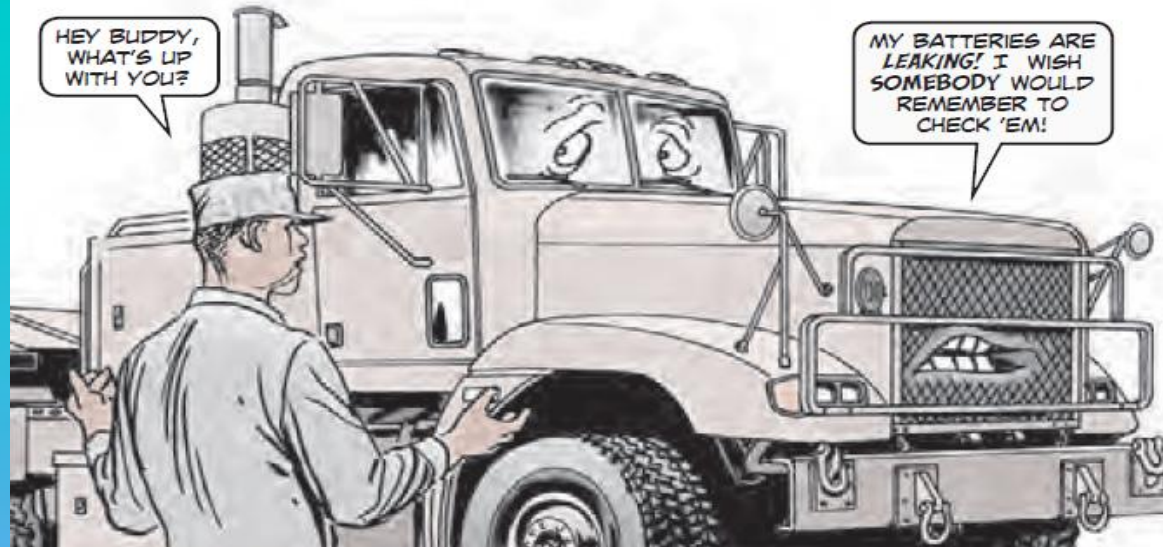
While servicing M920 tractor trucks, I've noticed a recurring problem. The wooden spacer plate, NSN 5365-01-079-6540, that goes under the batteries often rots and needs replacing. That part costs almost \$50.

It sure would be nice to have this plate last longer in bad weather and battery leakage. Do you have a tip that can help us?

Certainly. You still have to use the spacer plate, but here's a tip that should help you out. Use battery box liner, NSN 6160-01-389-1966.

The battery box liner should absorb and neutralize battery acid and prevent corrosion to the box. You'll have to cut enough liner to cover the entire bottom of your truck's battery box.

Then replace it whenever you need to.
